Subject: 12<sup>th</sup> Street Landfill – Emergency Action  
Status Update Report

This letter presents activities performed as part of the 12th Street landfill emergency action in Plainwell, Michigan, between September 1 and September 10, 2007. Equipment delivered to the site over this period included the final sheeting for the Portadams, 20,000-gallon storage tank, 200 gpm water treatment system, and off road dump truck.

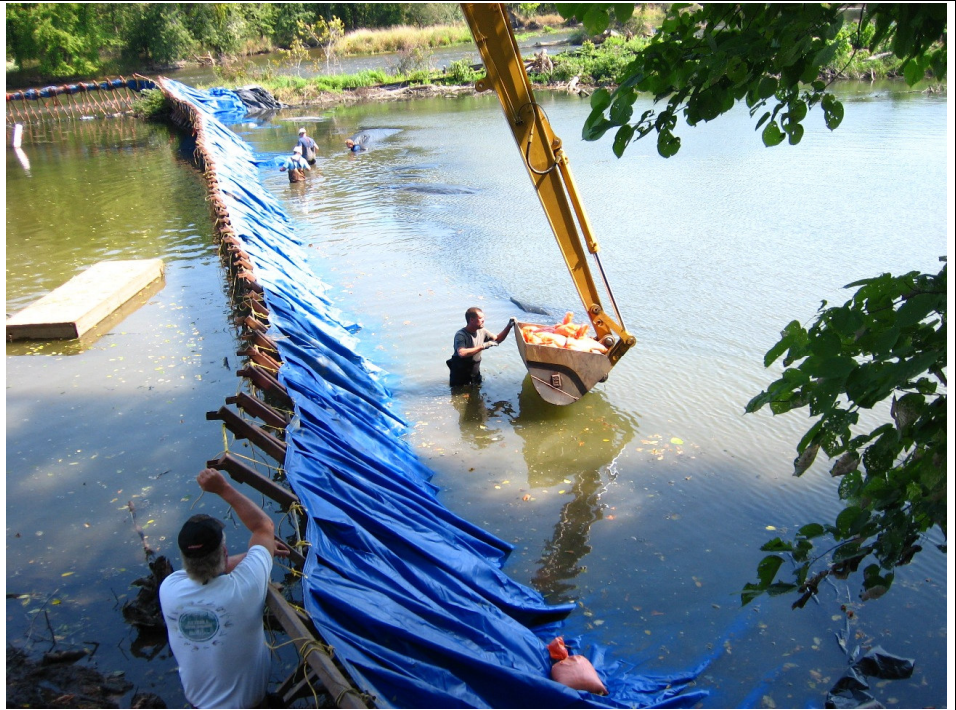
| Photo No.<br>3 | Date<br>9/5/07 | | |

| Description<br><br>Placing sandbags on portadam upstream | | | |

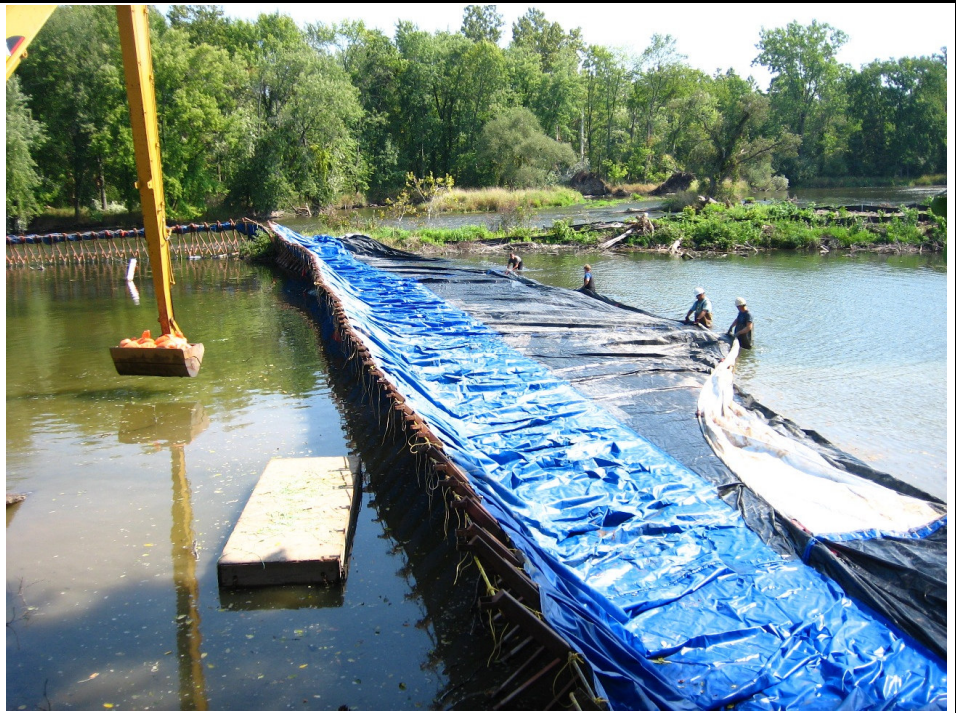
| Photo No.<br>4 | Date<br>9/5/07 | | |

| Description<br><br>Lay out curtain upstream | | | |

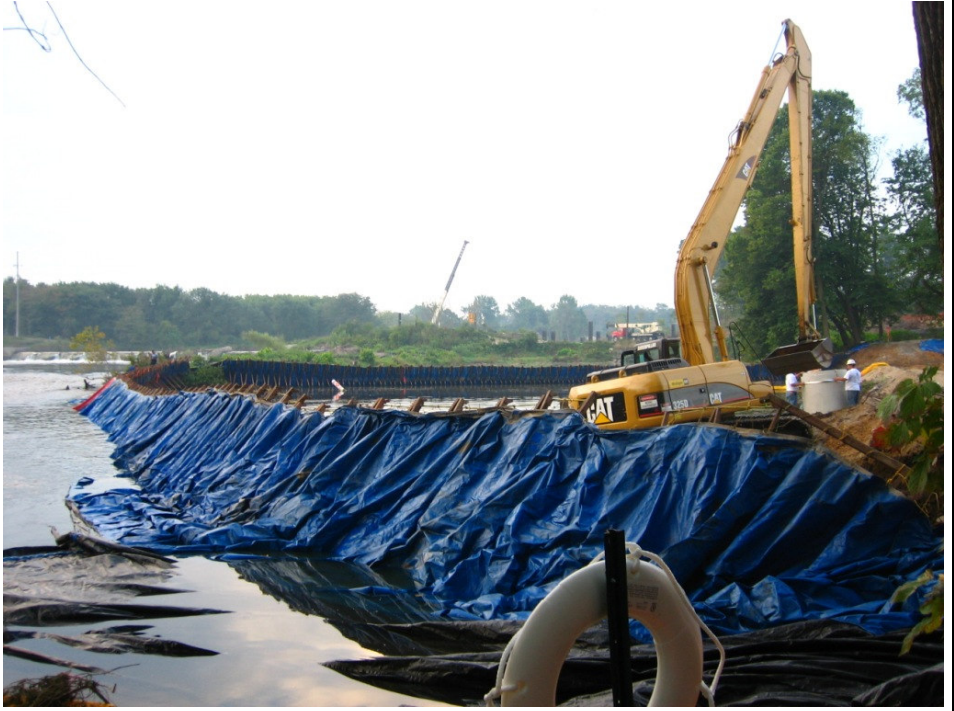
| Client Name: | | Site Location: | Project No.: |
|---|---|---|---|
| 5 | 9/6/07 | | |

| Client Name: | | Site Location: | Project No.: |
|---|---|---|---|
| Portadam placement downstream | | | |

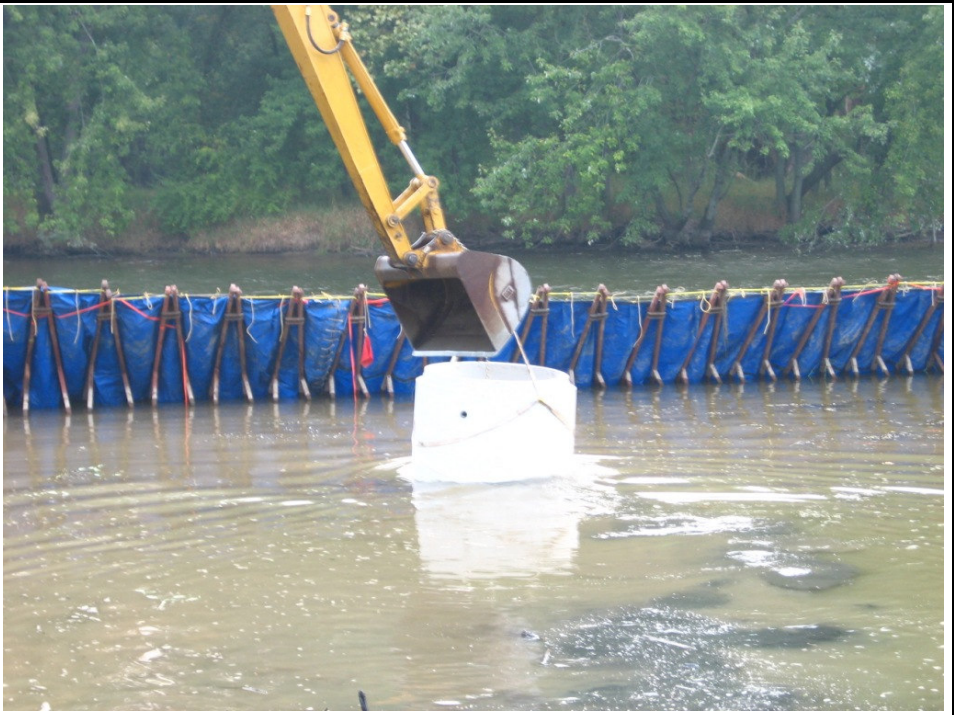
| 6 | 9/6/07 | |

| Place manhole for pumping channel | | |

- Placed curtain material on the Portadam structures. Placed continuous line of sandbags along edge of Portadam curtain.
- Placed concrete manhole into channel and placed pump into manhole. Began pumping down channel.

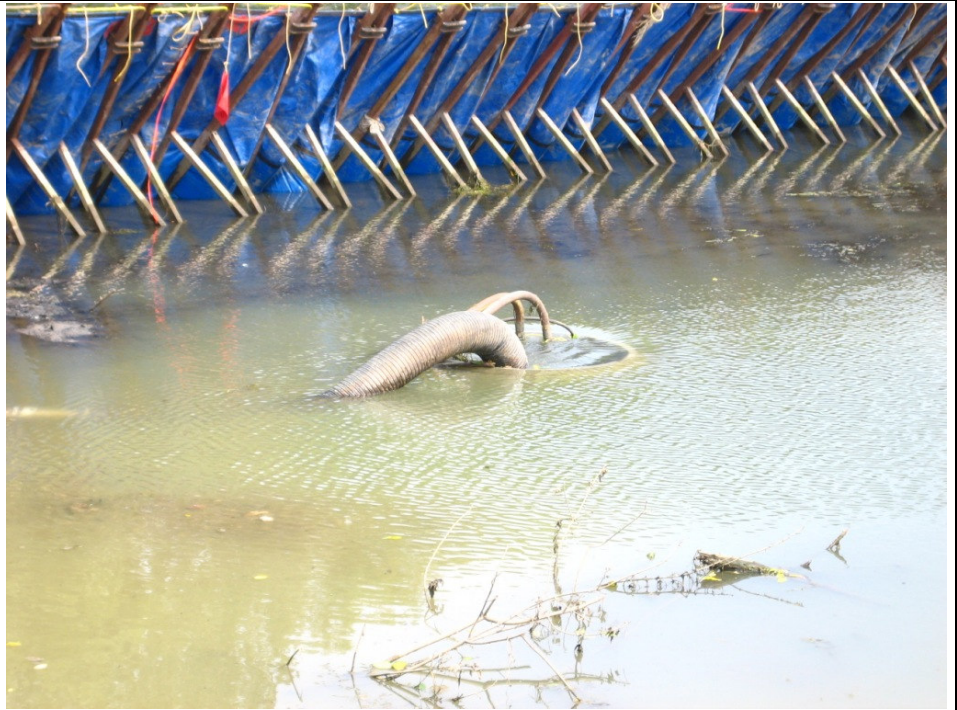
| Photo No.<br>7 | Date<br>9/6/07 | | |

| Description<br><br>Pump set within manhole | | | |

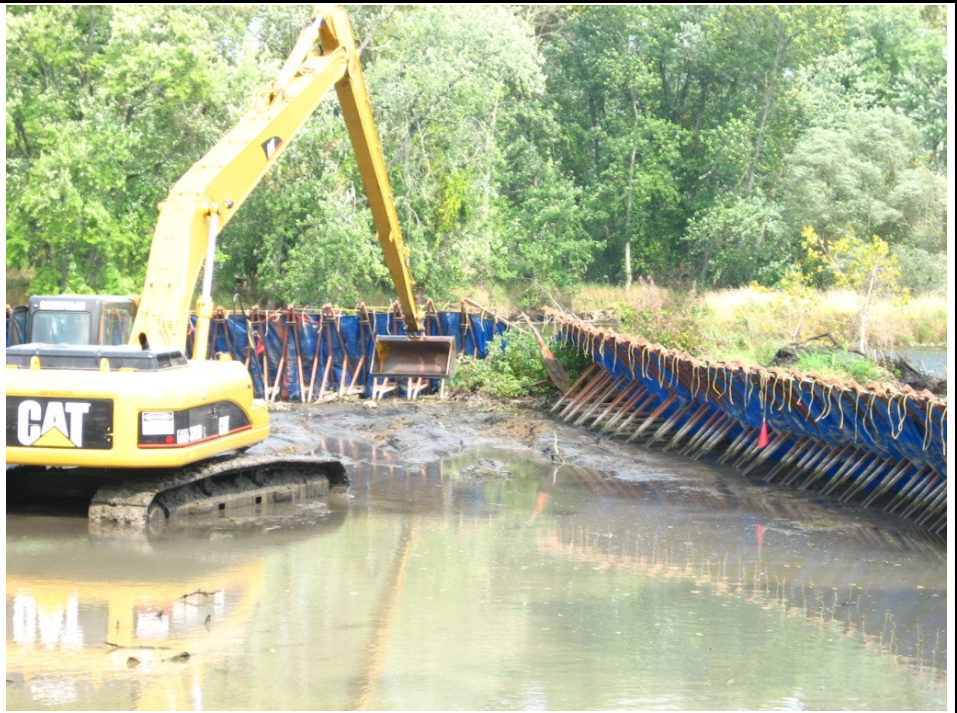
| Photo No.<br>8 | Date<br>9/6/07 | | |

| Description<br><br>Remove material from peninsula area | | | |

- Once area pumped down, sediments were removed starting at peninsula area and working back toward shoreline. Approximately 600 cubic yards of sediment were removed. Areas of residuals identified near peninsula and in sporadic locations along shoreline. All visual residuals removed and transported to containment pad.

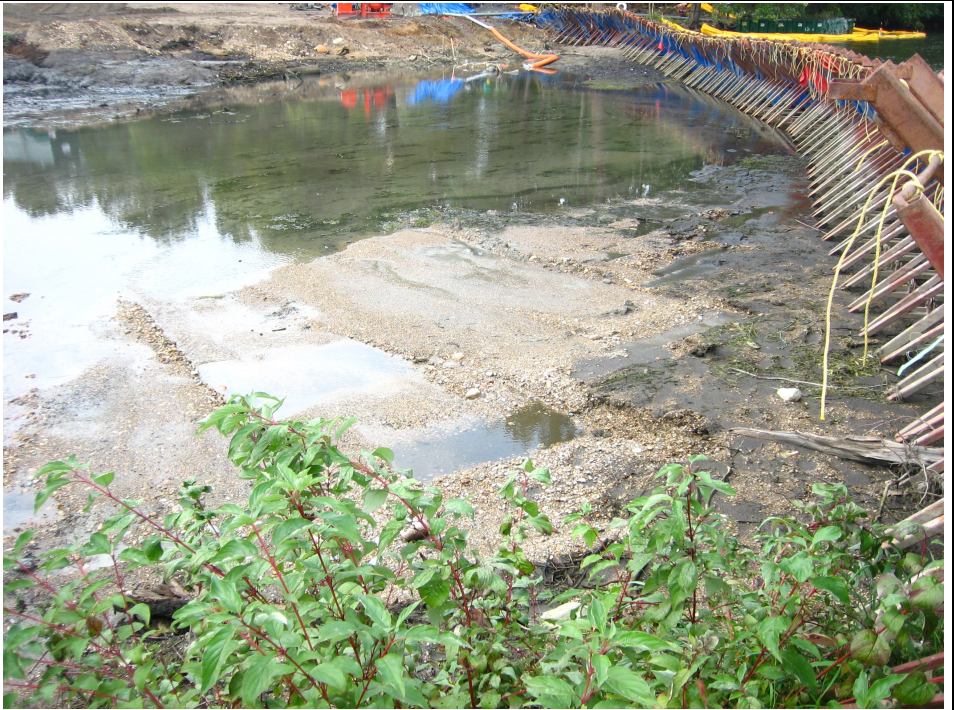
| <b>Photo No.</b><br>9 | <b>Date</b><br>9/7/07 | | |

| <b>Description</b><br>Peninsula area after excavation | | | |

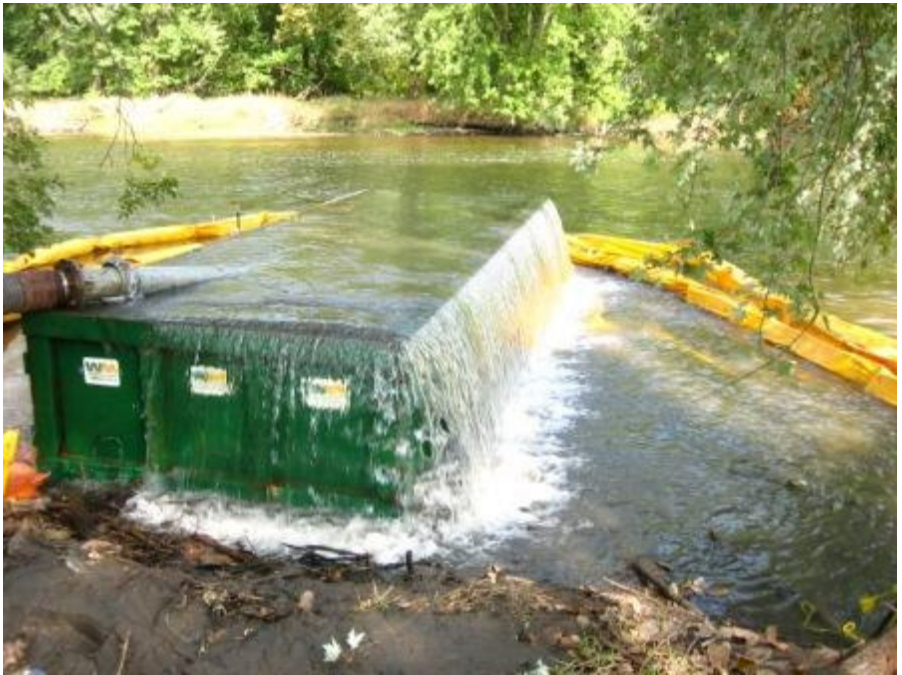
| <b>Photo No.</b><br>10 | <b>Date</b><br>9/8/07 | | |

| <b>Description</b><br>Dissipation tank and secondary containment area | | | |

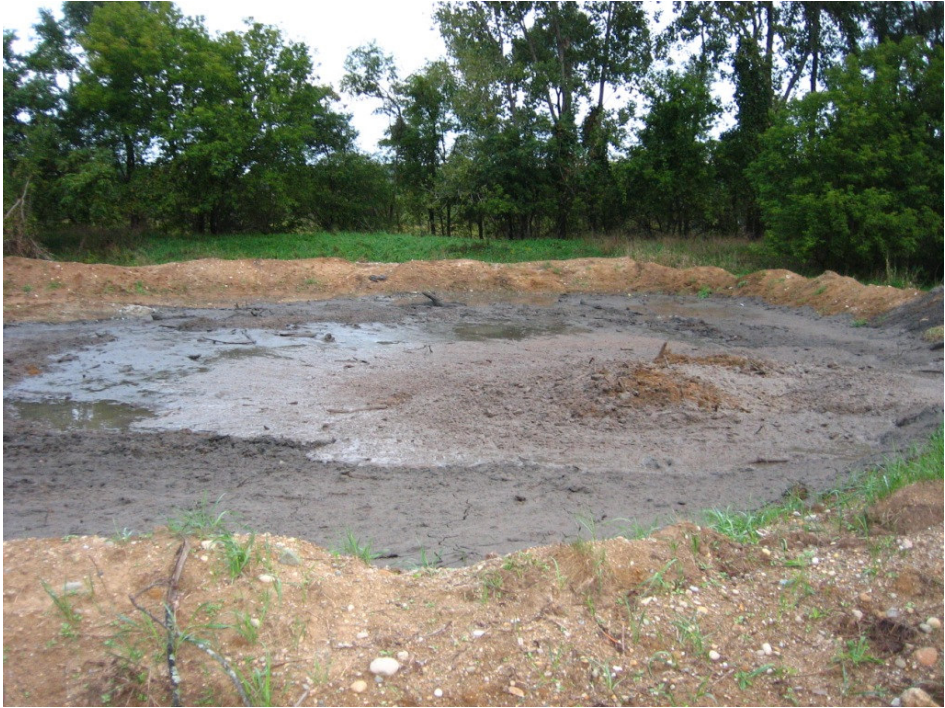
| Photo No.<br>11 | Date<br>9/8/07 | | |

| Description<br><br>Material within containment pad | | | |

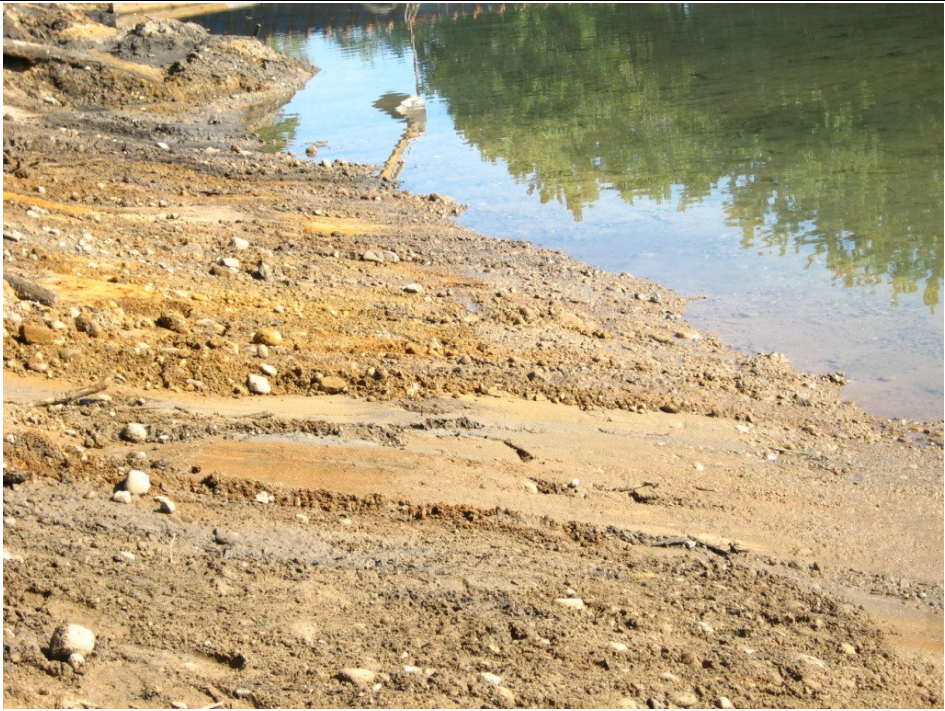
| Photo No.<br>12 | Date<br>9/9/07 | | |

| Description<br><br>Bank area begin reshaping | | | |

- Initial removal of sediment in channel was completed on September 10, 2007. Sampling of the channel was performed on September 11, 2007. Pumping of the area will continue to keep static head on Portadams until analytical results are received.
- Bank area was regraded to approximately 3:1 slope. Bank is consistently sand and gravel.

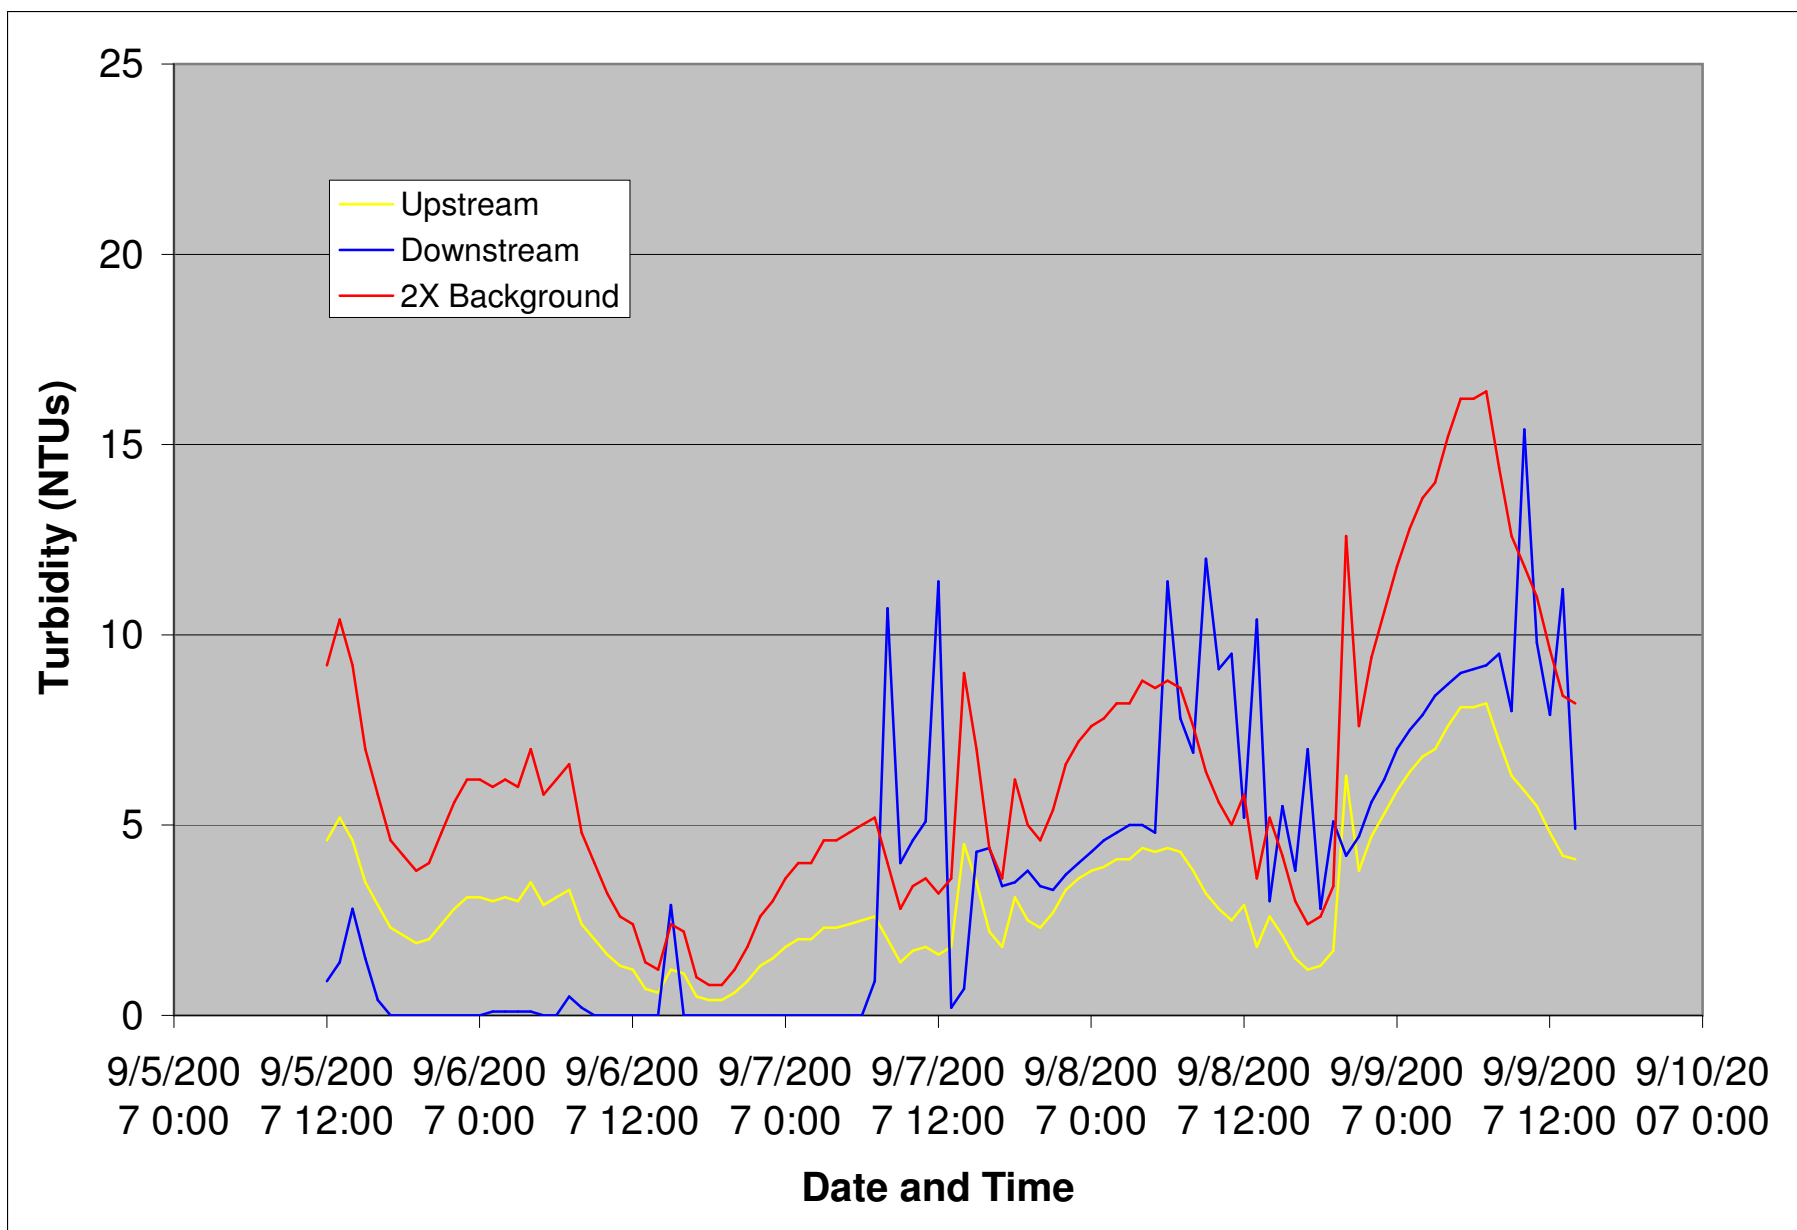
resuspended sediment. These actions slowed the emergency excavation activities. Both a tabular summary of turbidity data and a graphical representation of these results are attached to this report.
